Summary of key results of the state of Ventilated Improved Pit Toilets in informal settlements in the City of Johannesburg

September 2024

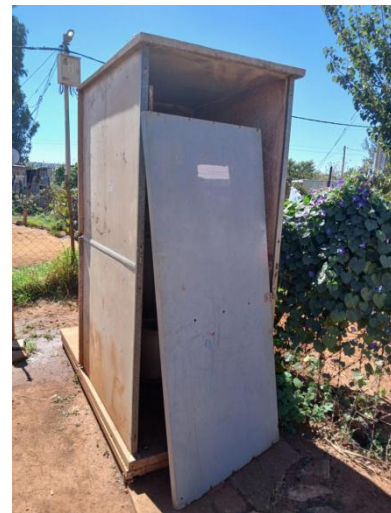
1.1. 50% of toilets have broken doors and/or cannot lock

Half of all the toilets mapped did not have a working door and/or lock. This has a major impact on user safety, particularly on vulnerable groups such as women and children. Toilets that cannot be locked from the outside pose an additional risk of injury or worse to children if they play in toilets. Residents also reported difficulties in finding replacement doors and locks, as the design of their toilets does not accommodate replacement parts commonly available on the market.

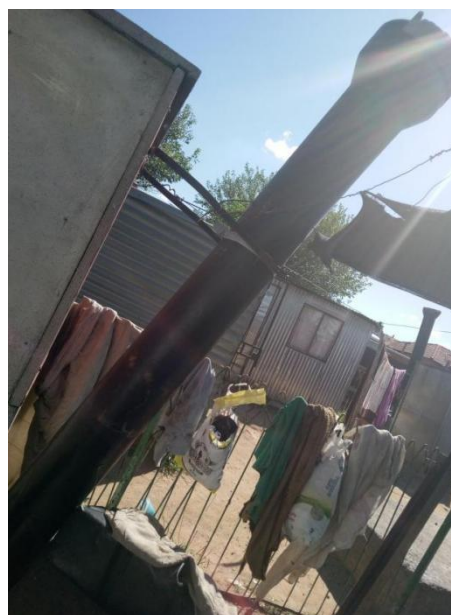
1.4. 60% of toilets had an unstable chamber

Stable chambers are crucial for preventing environmental contamination and ensuring effective desludging by contractors. Unstable chambers can lead excreta seeping groundwater or soil, which could have severe consequences on the environment, as well as health.

Many informal settlements in Johannesburg are built on areas with dolomitic soil⁴, which creates an additional concern that leaking excreta from unstable chambers can destabilise the rock structure and lead to the formation of sink holes.⁵

Residents are ill-equipped to bear the responsibility of pit chamber repairs and maintenance, as this requires specialised skills and the consequences if not done correctly or at all can be severe.

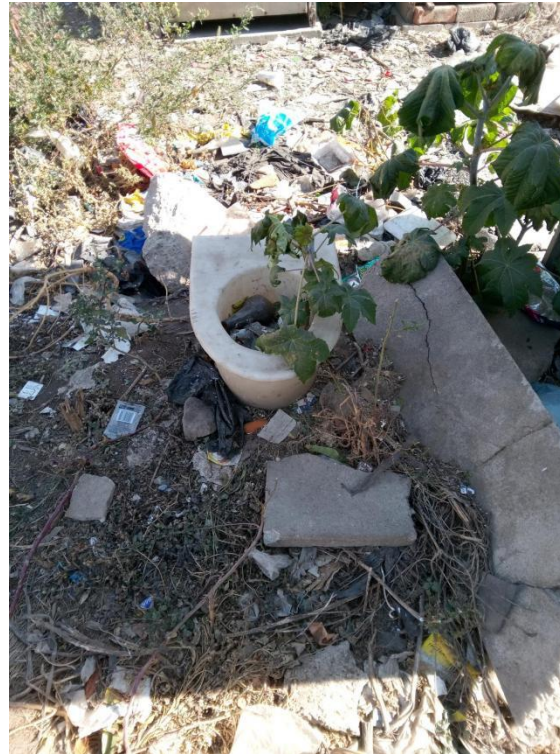
1.8. Old and dilapidated toilets

More than 50% of all toilets surveyed were older than 15 years, with 32% older than 20 years.

This data reveals that VIP toilets are used for well beyond their estimated lifespan of 5-7 years, and that they have become more of a permanent solution than an interim one. It is evident that there is no protocol for what happens when VIPs reaches the end of their lifespan. Additionally, where toilets have been demolished, they have not been decommissioned, posing an ongoing risk to health and safety.

- **Lifespan:** Define how long a VIP should be used by a household.
- **End-of-life reporting protocol:** Outline the process for reporting dilapidated VIP toilets, including the actions the municipality will take once reported.
- **Decommissioning VIPs:** Create a structured approach for decommissioning demolished toilets, including the timeframes for decommissioning.
