Summary of key sanitation results for Buffalo City Metropolitan Municipality's informal settlements

October 2024

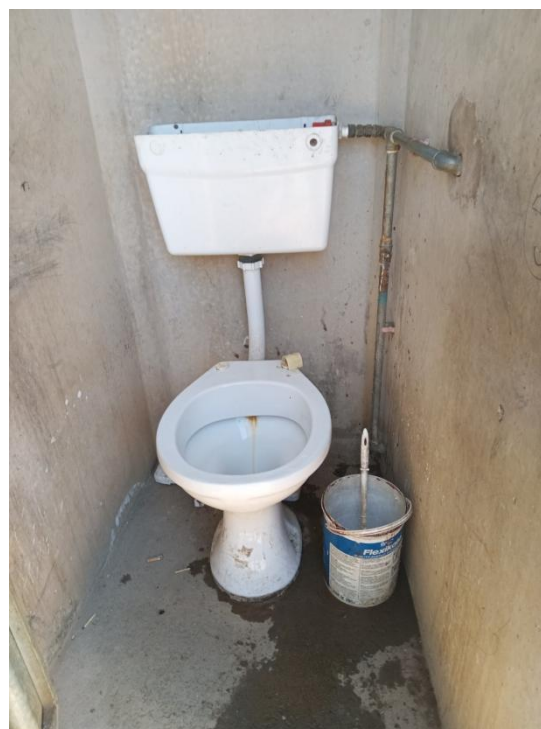
The most prevalent issue, found in 70% of toilets mapped, was that the **flushing mechanism** was broken.

Other key issues were dirty toilets, toilet doors with no locks or that could not be locked from the inside, and too many people sharing toilets.

What is wrong? (could tick more than one)	Number of toilets with the issue	% Share of total toilets mapped
Nothing is wrong	2	4%
No door	2	4%
No lock on door	22	39%
Door cannot lock from the inside	20	35%
Broken door	16	28%
Too many people sharing it	31	54%
Toilet is blocked	14	25%
Toilet is vandalised	12	21%
Flushing mechanism is broken	40	70%
No Water	17	30%
Toilet is dirty	26	46%
Cistern is leaking	15	26%
There is trash in the toilet	14	25%
No seat	19	33%
Broken seat	6	11%
Other	21	37%
Total number of toilets mapped	57

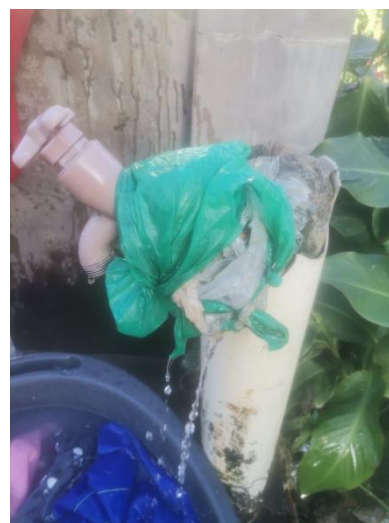
Key issues with communal standpipes:

- Broken tap(50%)
- Leaking tap (45%)
- No drainage under the tap (35%)
- Too many people sharing the tap (35%)
- Other (35%)
 - **Other** included: no water in the area, blocked drains, drains without lids, and no tap at all.
- No water (5%)
- Trash in the drain under the tap (5%).

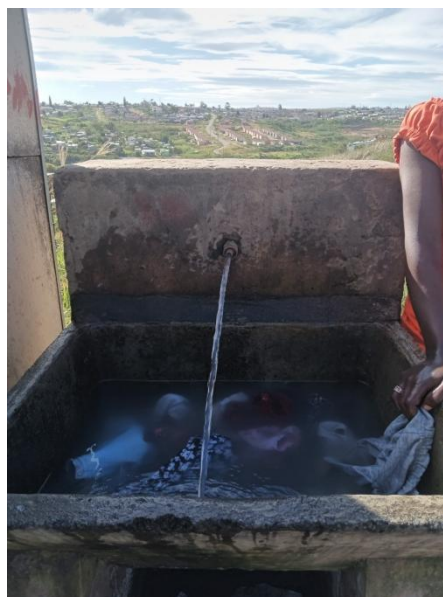
Key issues with taps with basins:

- Other (37%)
 - **Other** included: No drainage system, blocked drains, leaking pipes under the basin, pipes below the basin had been cut, no pipes below the basin, no water connection to the tap, and issues with stench.
- No tap (31%)
- Broken tap (29%)
- No water (23%)
- Low water pressure (11%)
- Blocked basin(11%)
